**Informal Dispute Resolution
Presentation
By
Fields Brook Action Group
To
U.S. Environmental Protection Agency

Regarding
Detrex – Fields Brook DNAPL Issues

May 31, 2006
Cleveland, Ohio**

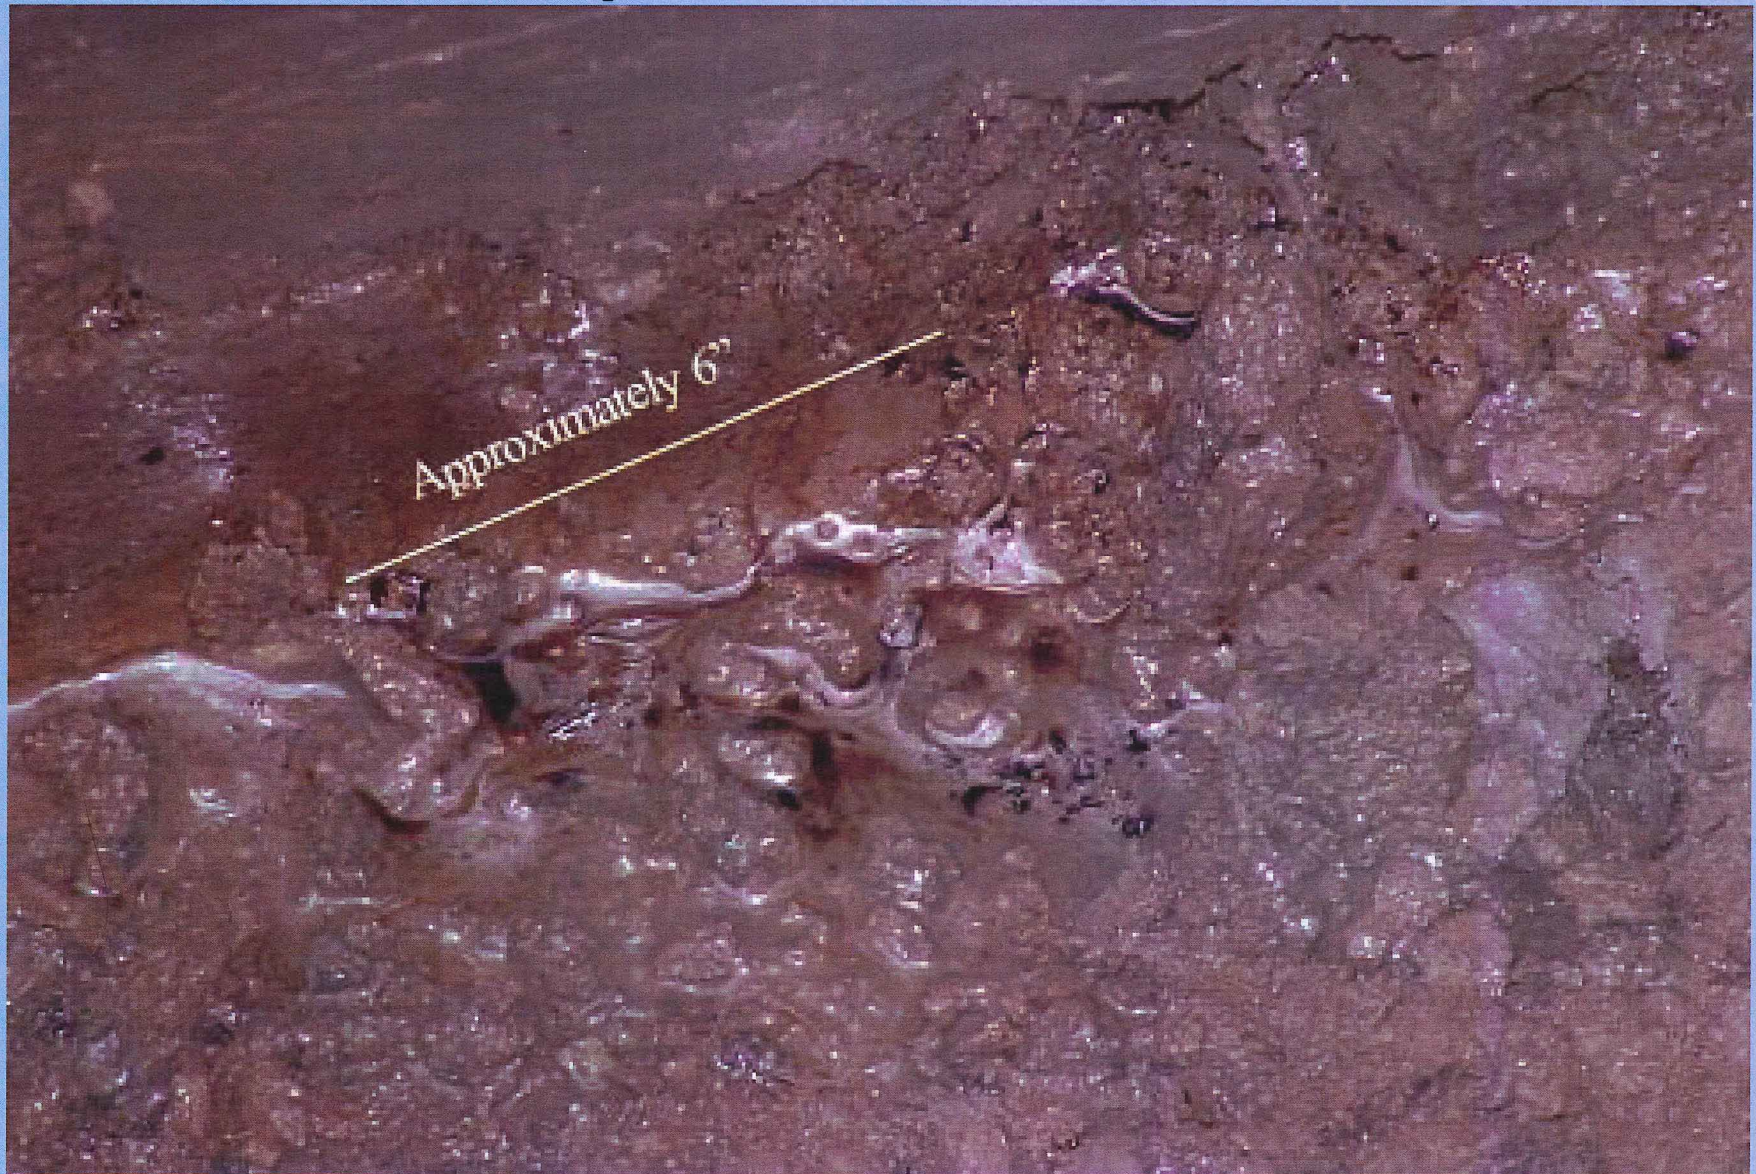
Example of DNAPL in 2005

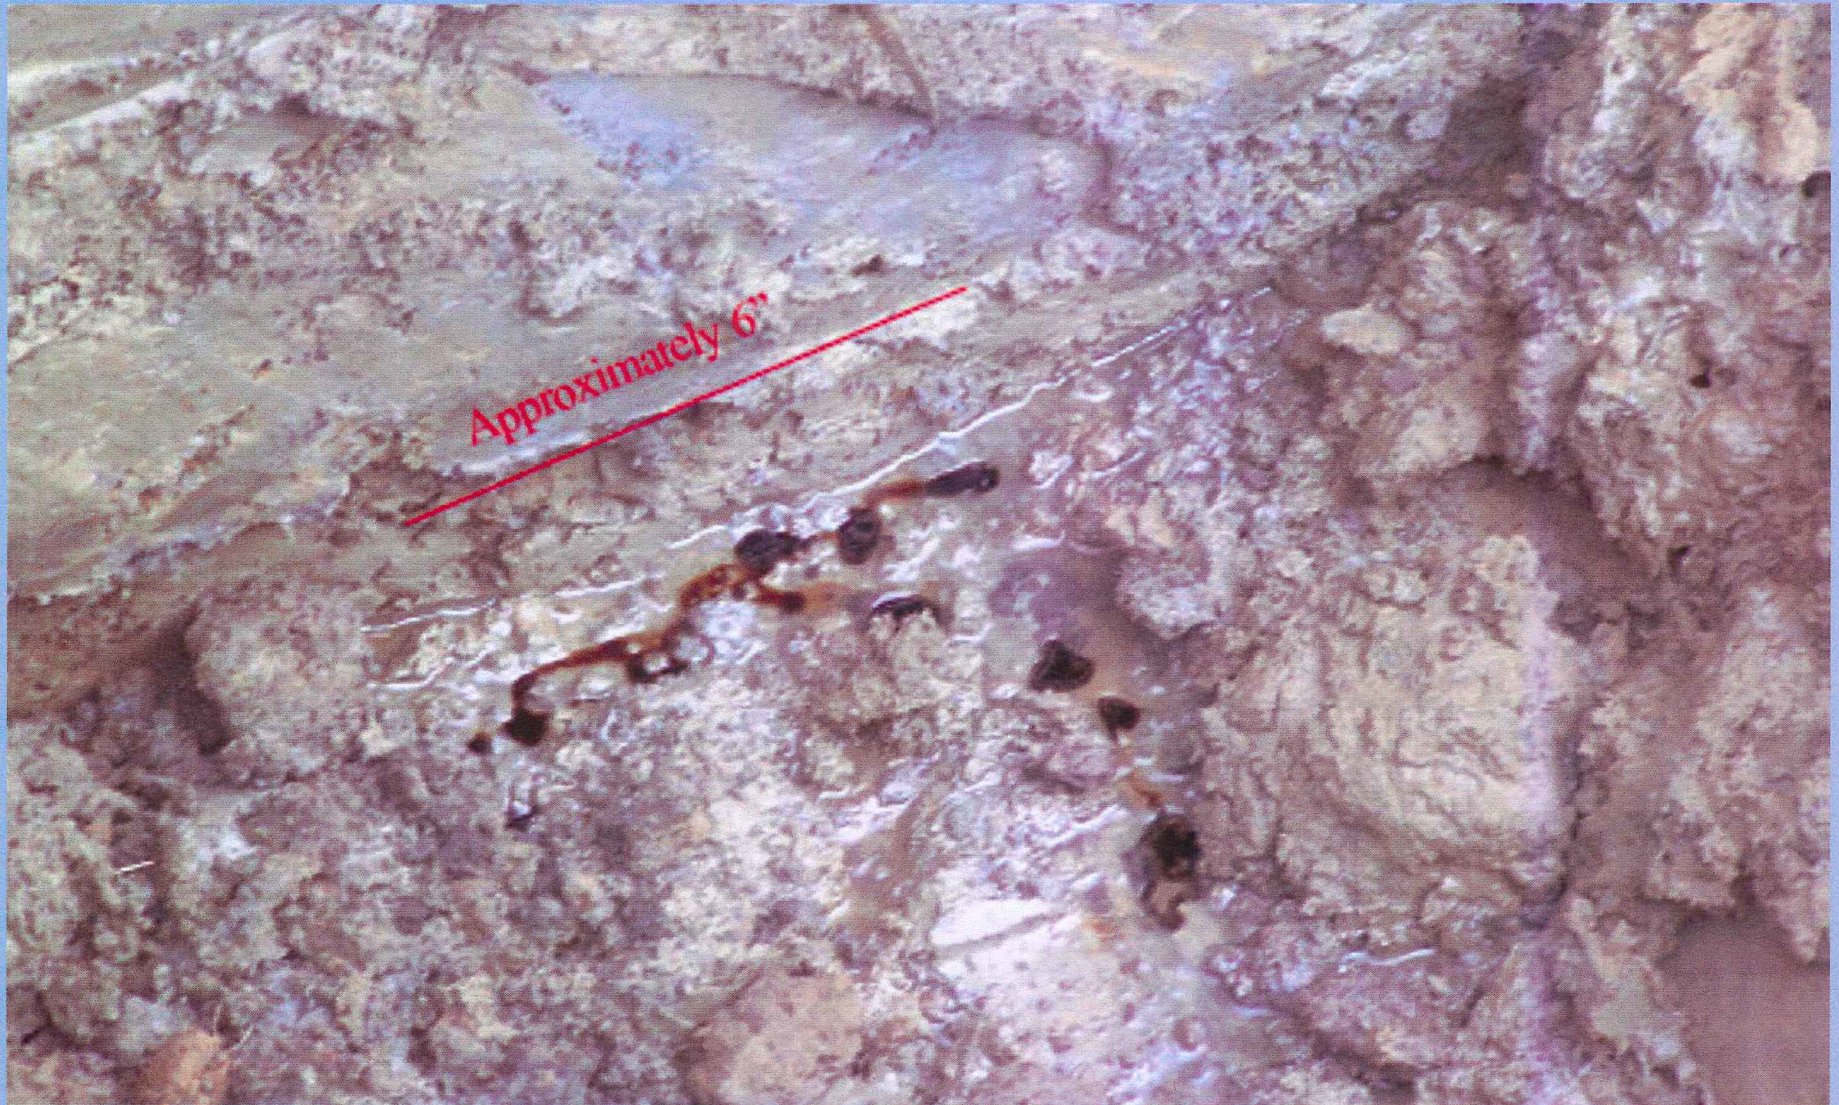
Example of DNAPL in 2005

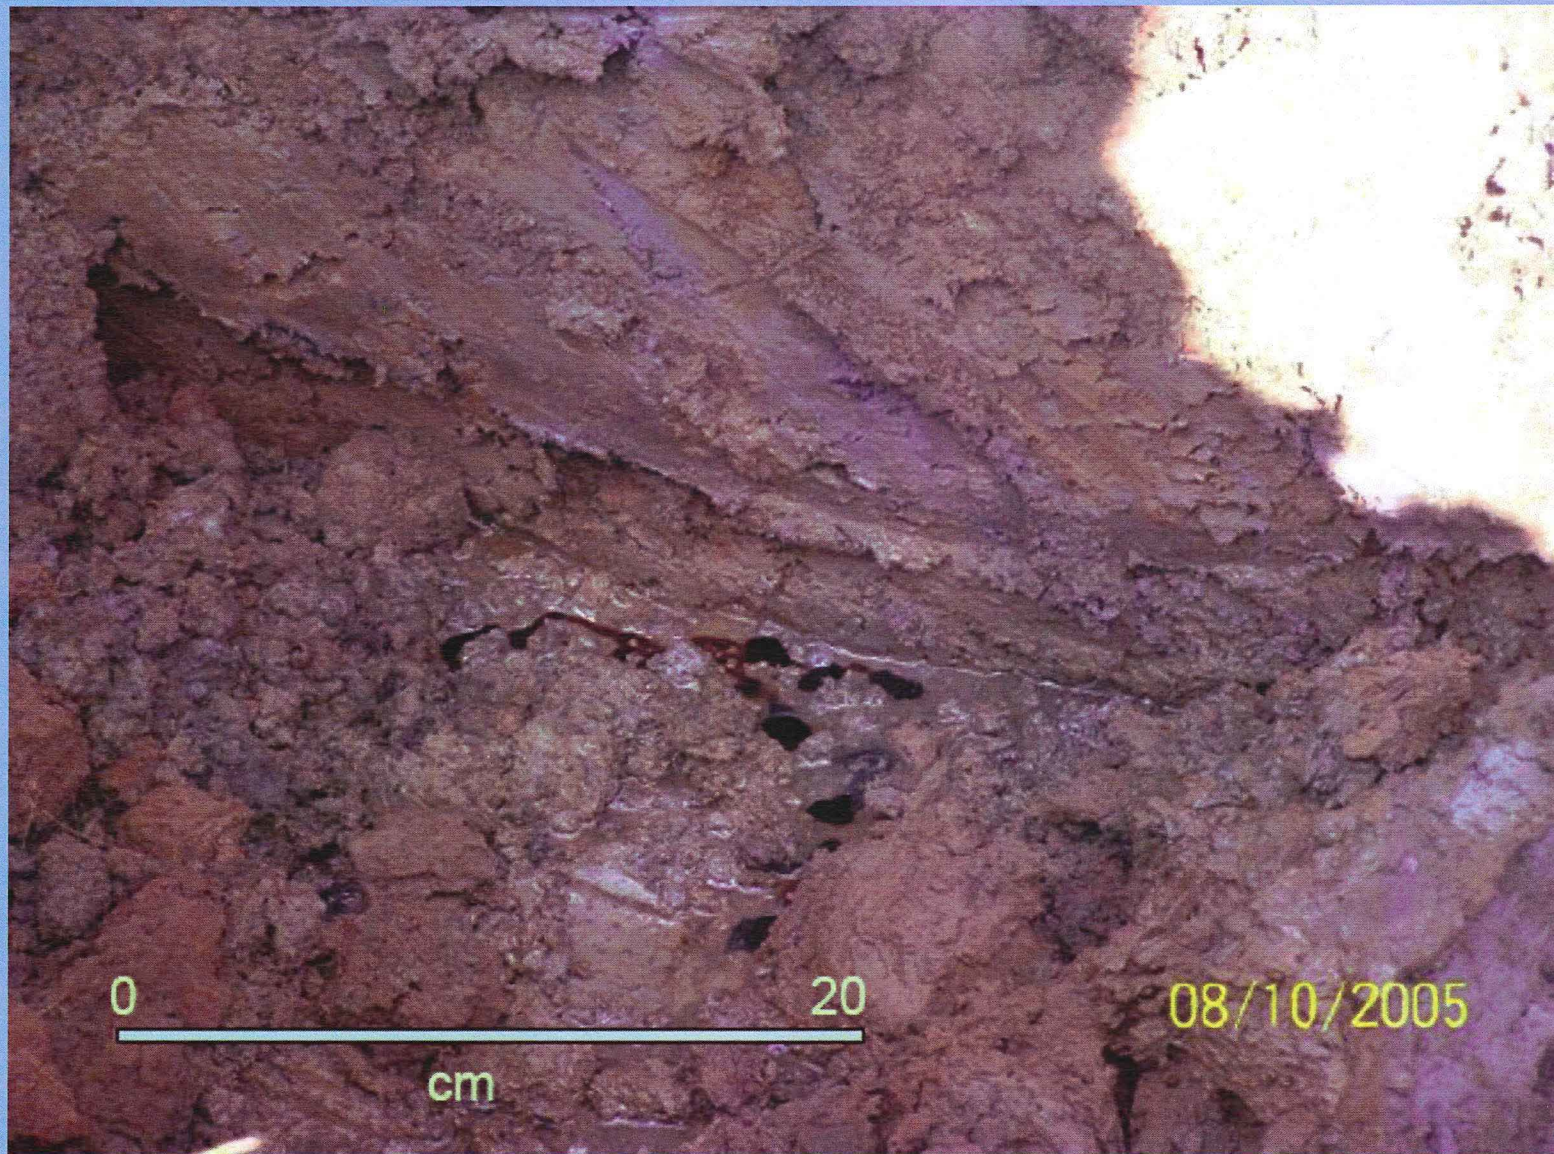
Example of DNAPL 2005

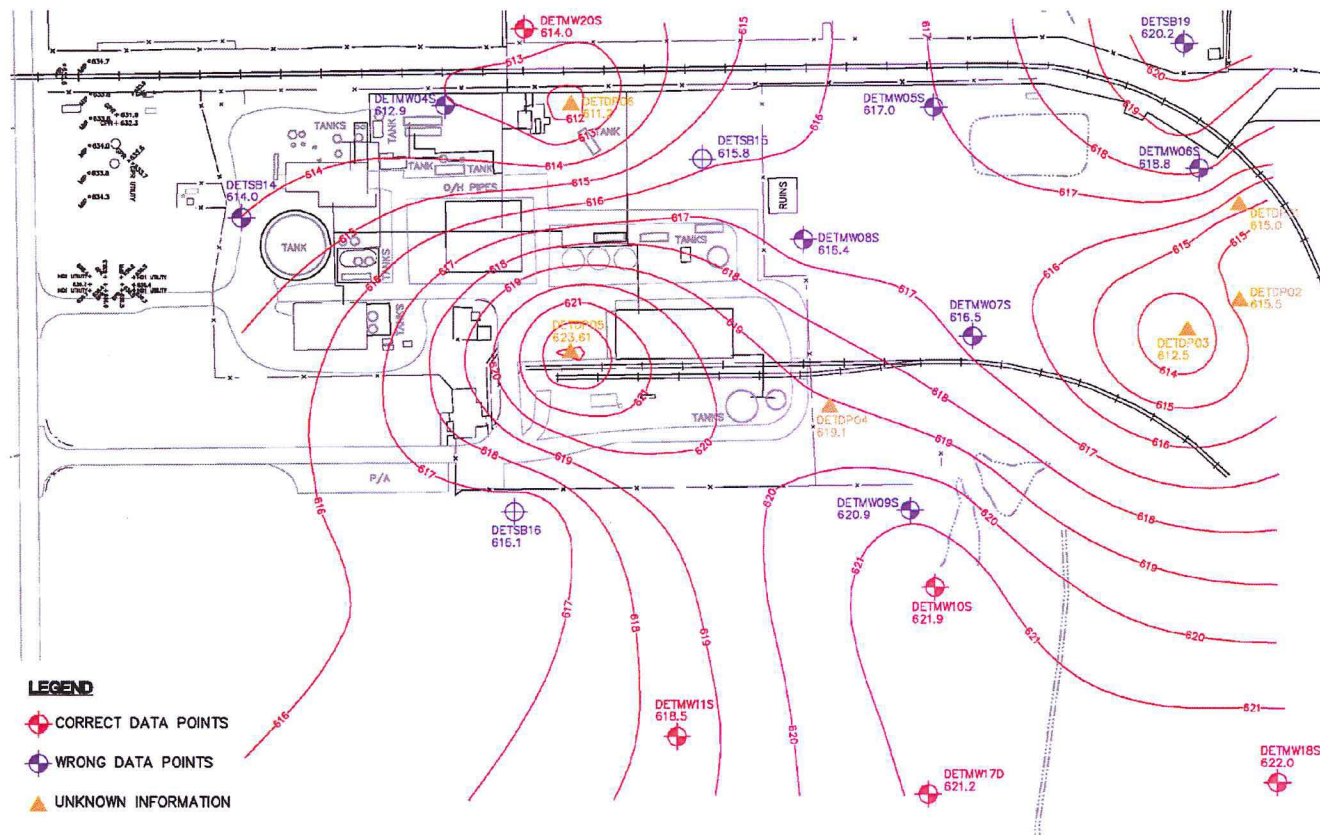
DETREX Top of Till Map Is Incorrect

Elevation used on Detrex map
 was 5 ft below bottom elevation,
 id est, 612.9 ft

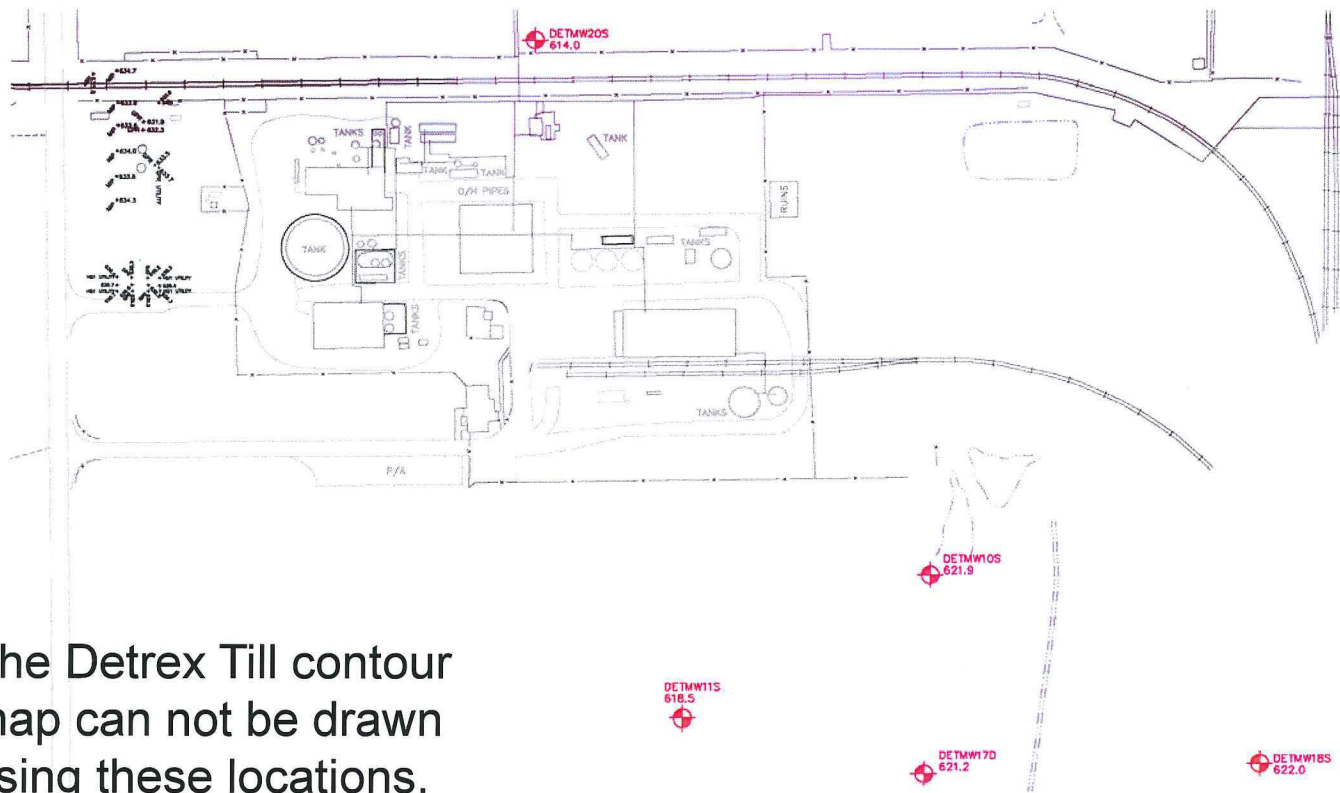
Actual Well Locations Where Till Was Shown on Boring Logs

The Detrex Till contour map can not be drawn using these locations.

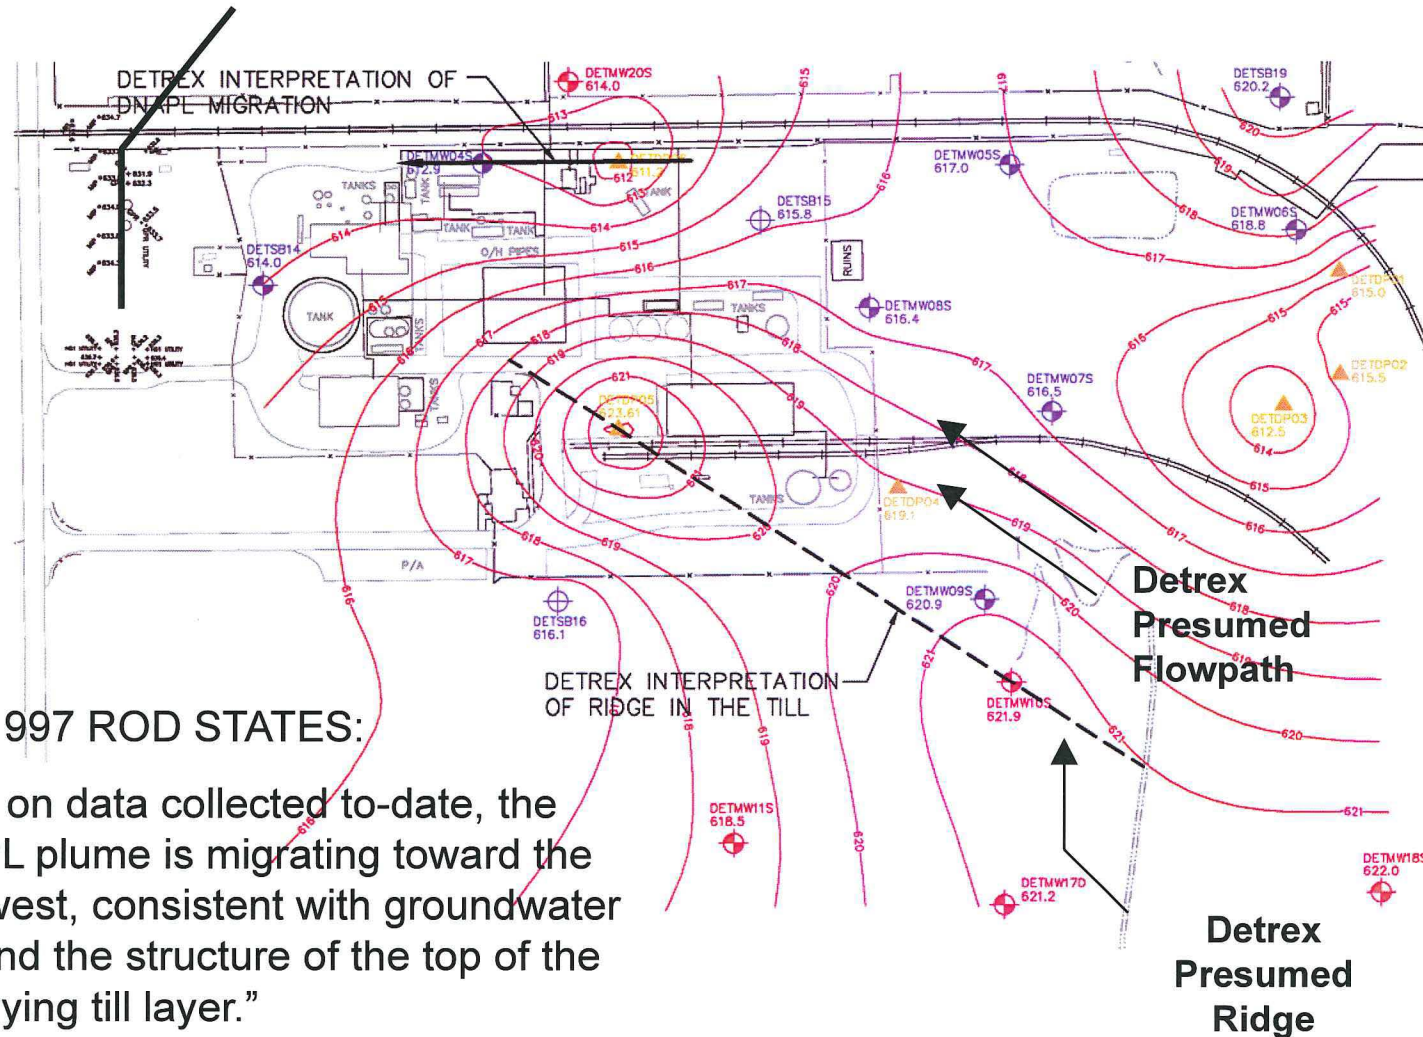
The Detrex Geologic Site Model Was Incorrect and the Ridge in the Till Did Not Stop DNAPL Migration to Fields Brook

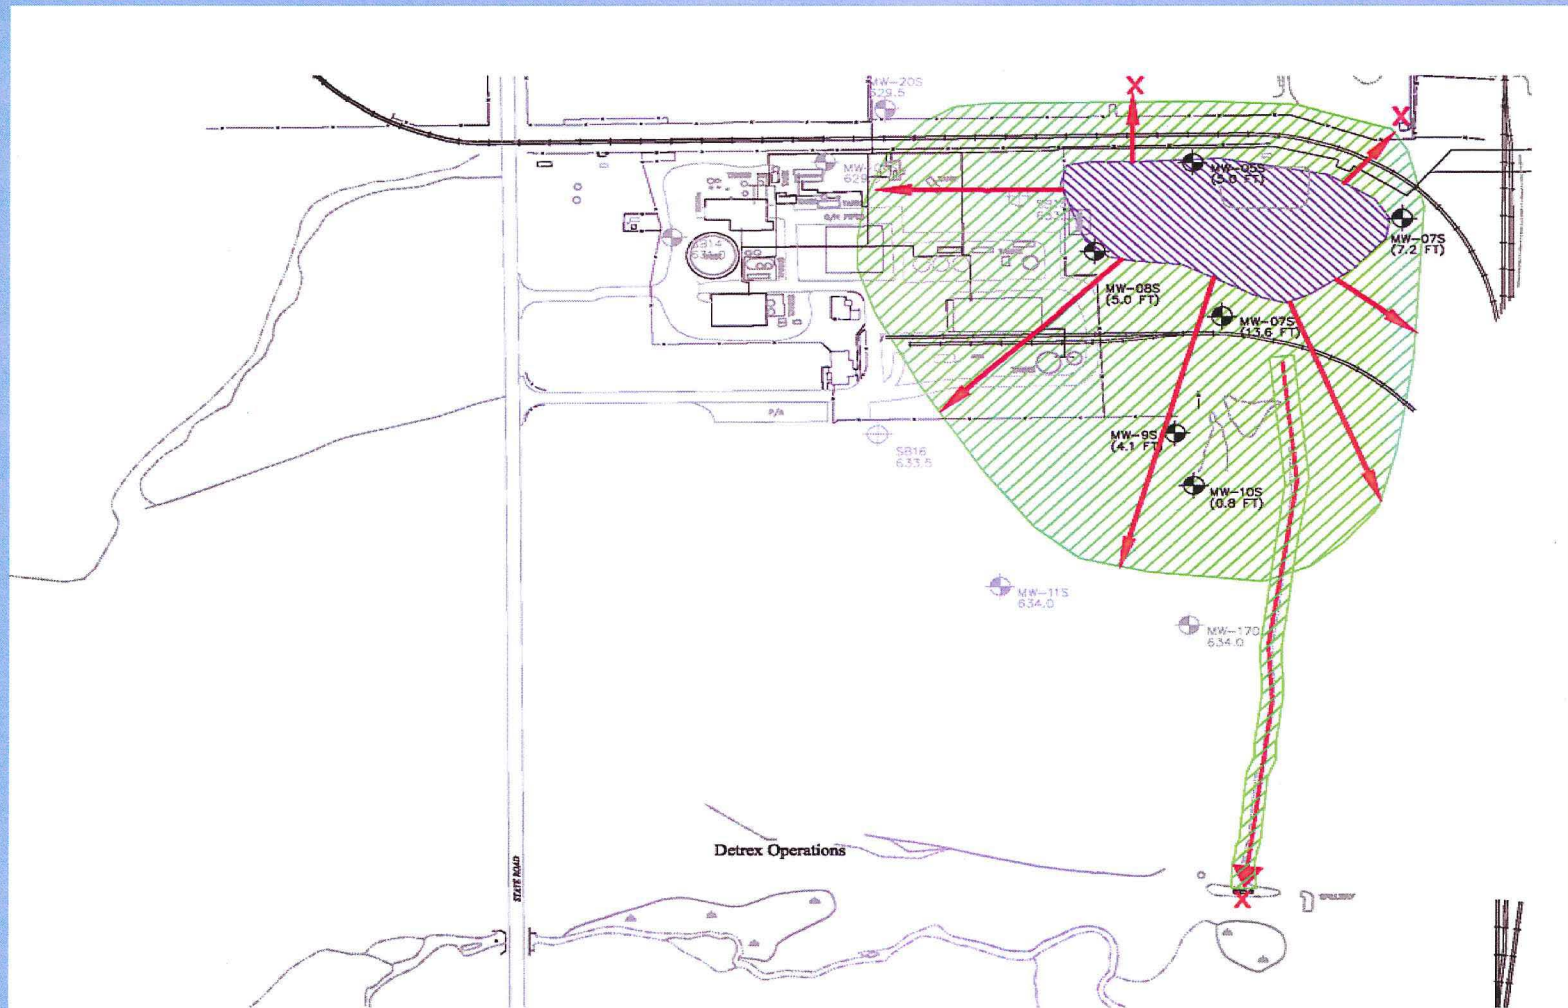
Locations of DNAPL Outside of the Detrex Source Area That Were Known in 2000 and Should Have Been Included in the Source Area Depiction

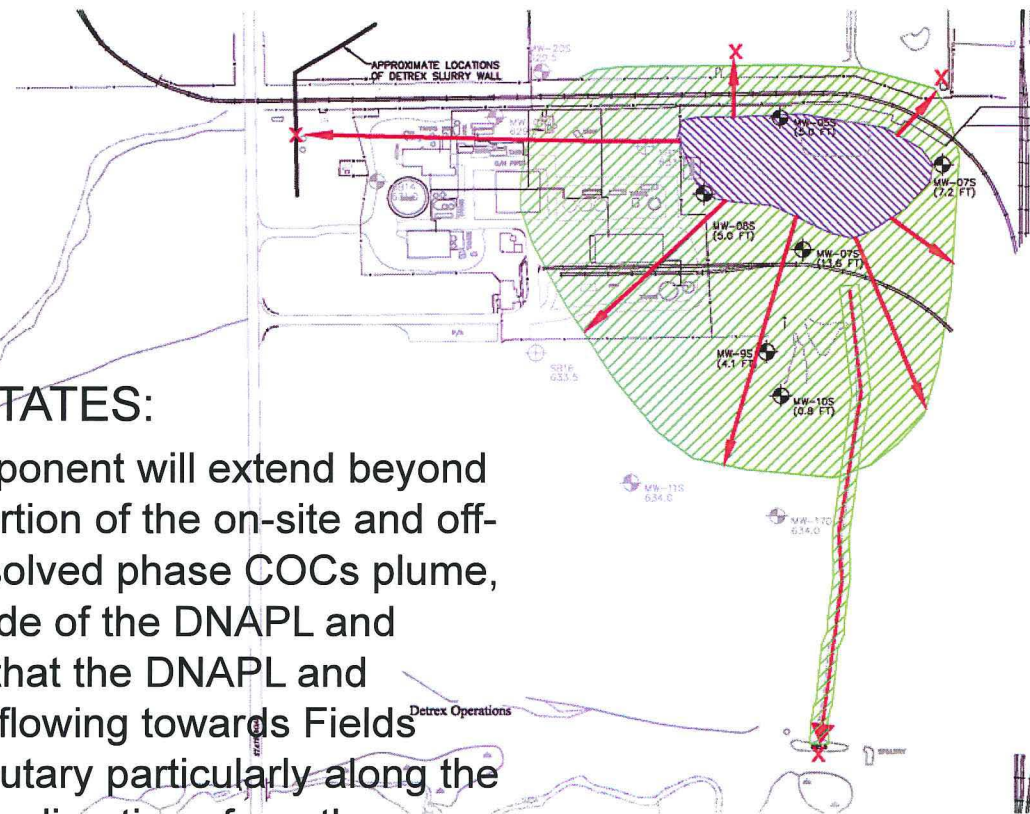
DNAPL Was Found at the Slurry Wall When It Was Installed in 2000/2001 – The Wall is in the Wrong Location

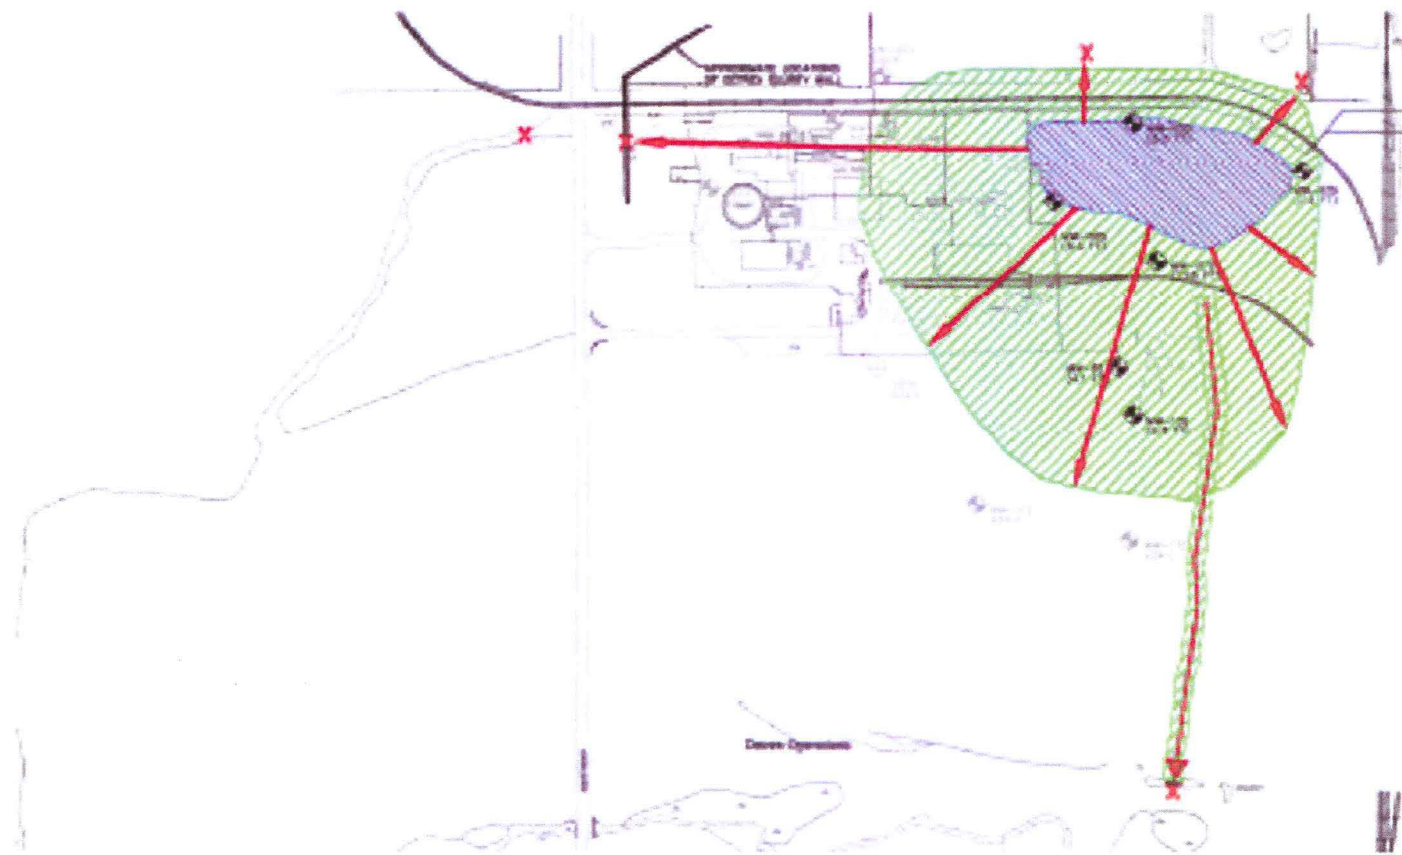
**DNAPL Was Found Beyond the Slurry Wall in the DS
Tributary in 2005 – The Slurry Wall Has Not Stopped
DNAPL Migration From the Detrex Source Area**

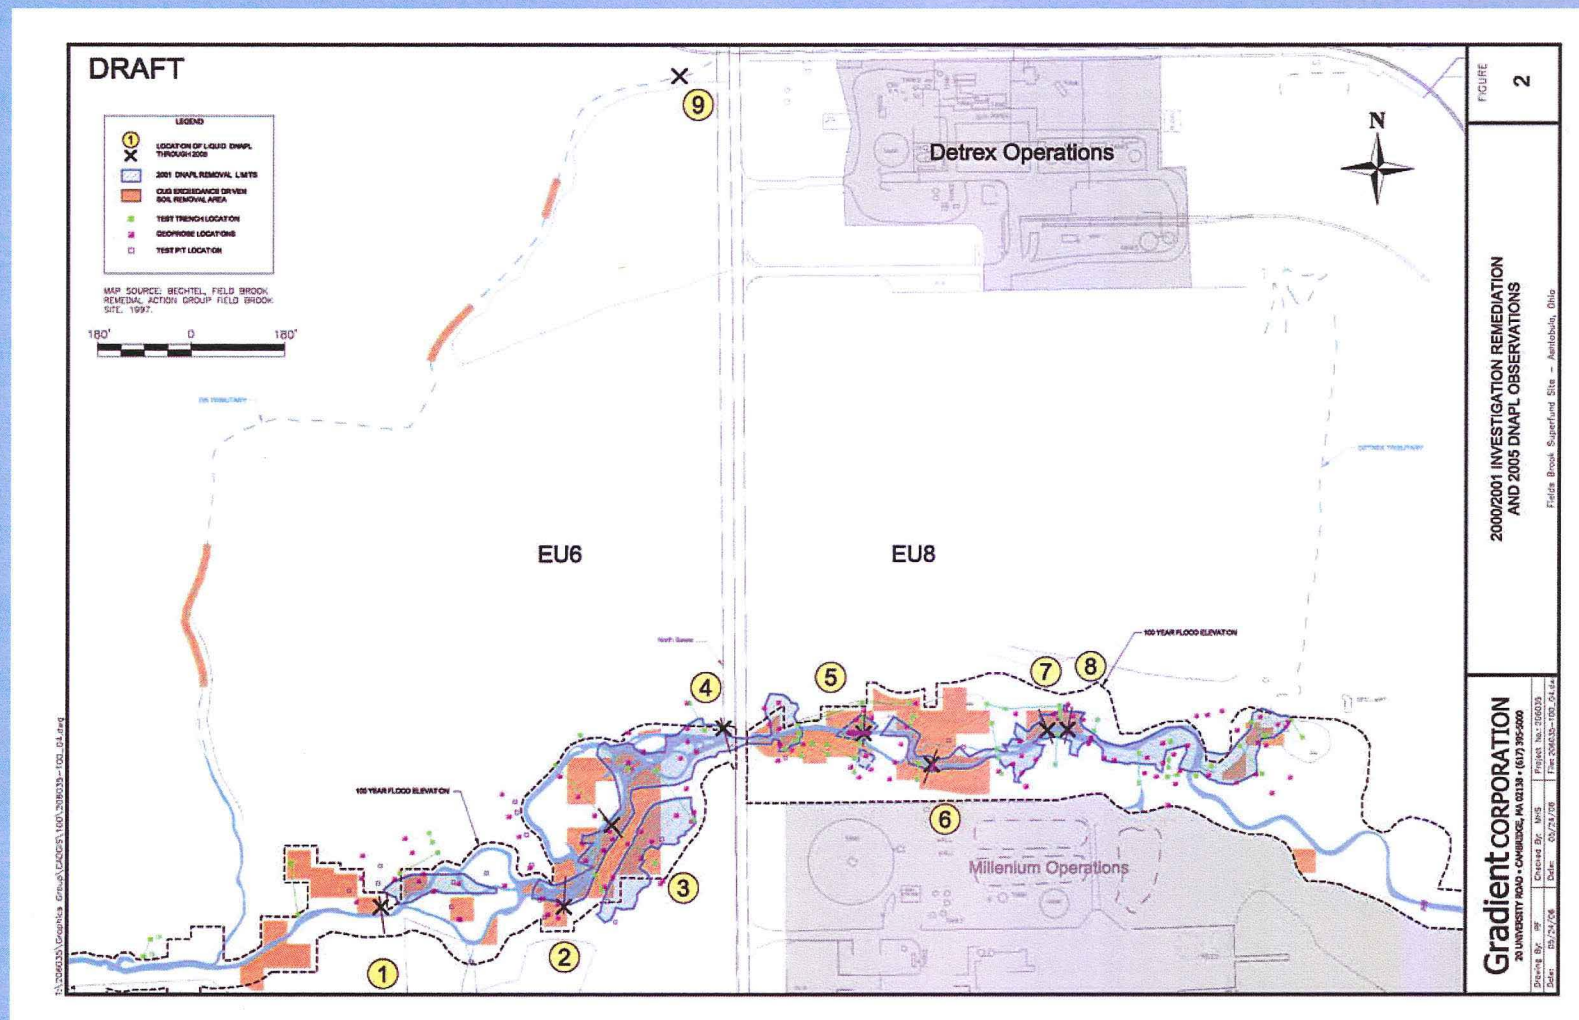
2005 DNAPL Observations

- **DNAPL found 6'–8' below ground surface in floodplain (2'–4' below stream bed)**
- **No evidence of 'top–down' migration from streambed**
- **Subsurface migration pathways: top of clay and till, sand seams and fractures (historically and at present)**

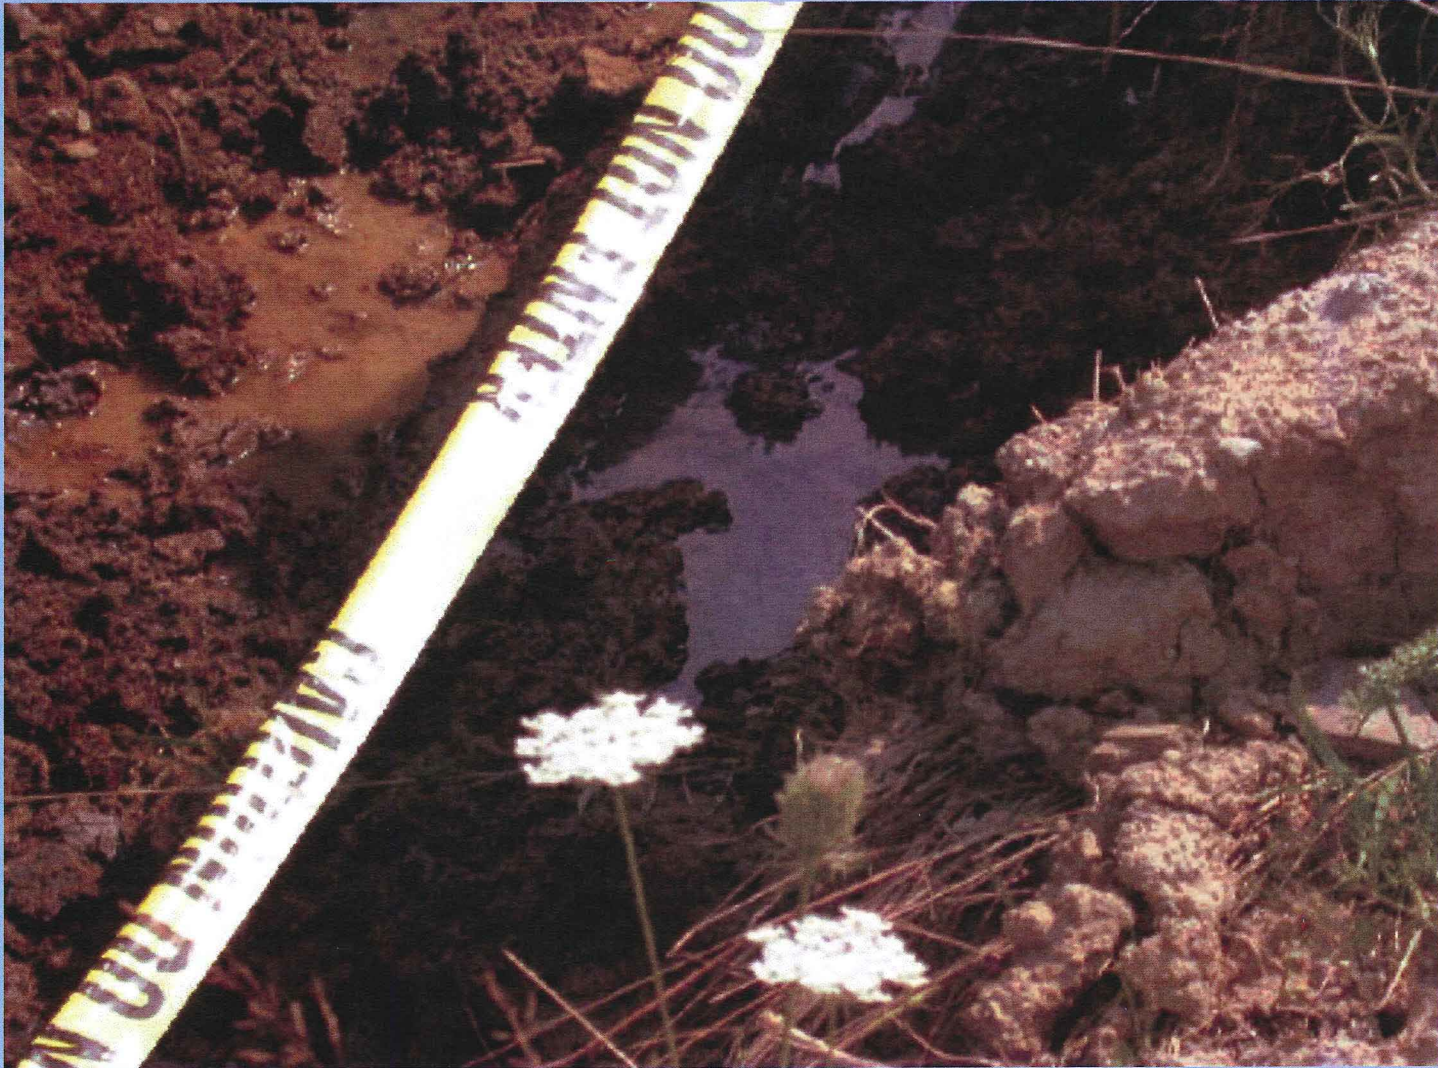
Sheen in Trench at Various Locations
